Rail on the Pre-Slit Table stucked

Antonio and Pere. January 24th, 2018

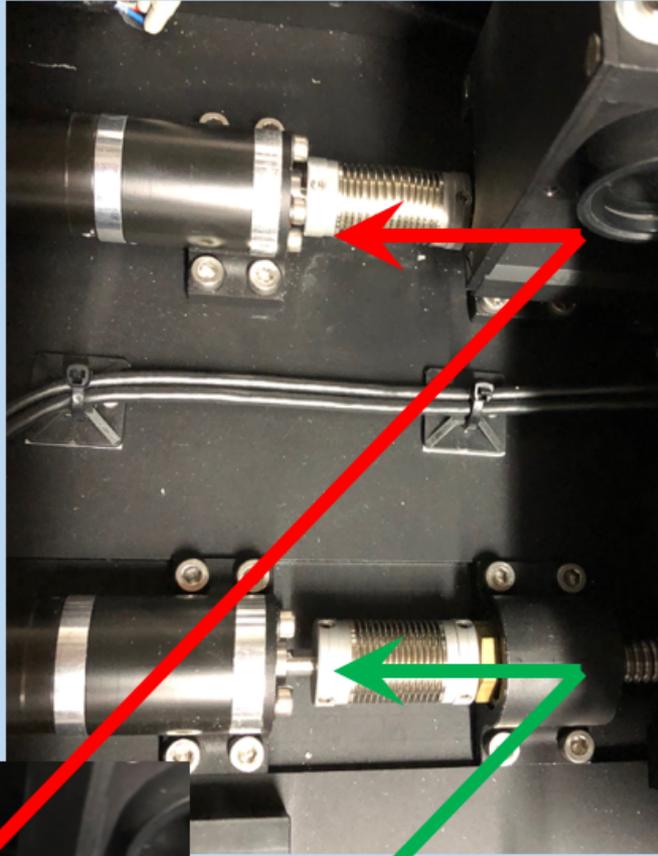
Before

Identified the unit and proceed according to the instructions received from Anton. Shown in Figure 1 (top) how the setup was found. By comparing both motorized rails (the one with the different fibres and the other with the iodine cell, first things we noticed was that:

- a) The bellow was expanded (as compare with the equivalent mounted with at the Iodine cell).
- b) It was "almost" touching the screws on the motor mounting.
- c) YES ! ! ! It was hard (very hard) to move it by hand (as compared with smoother movement of the other rail with I2 cell)

The grease on the nut (driven by the spindle) was completely SOLID ! ! ! and this prevents for a proper and smooth motion. At that point we cleaned it and use 4W (a non-silicone thermal grease) that will not become solid by any means. Everything smooth immediately after applying it! ! !
